• August 15-18, 2010 • Dallas, Texas •
• Dallas Convention Center •

Sandia National Laboratories In-House Retrocommissioning

Michael Rocco, CEM
Facilities Controls System Team Leader

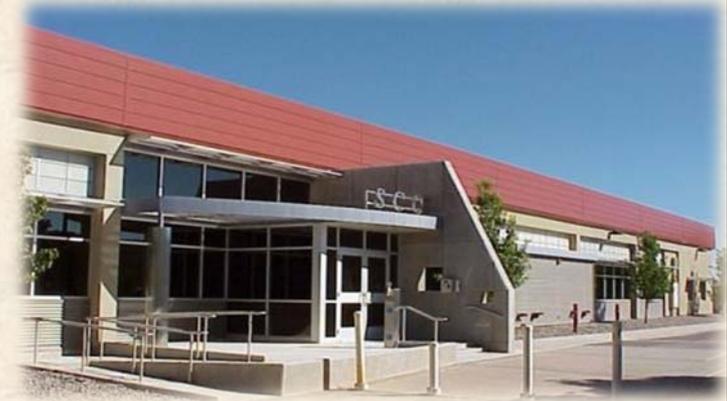
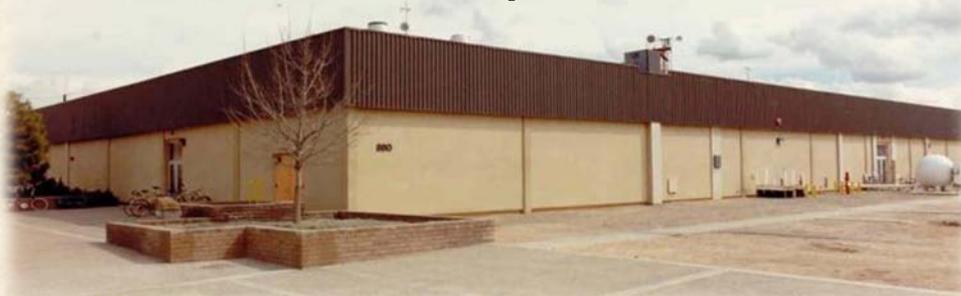
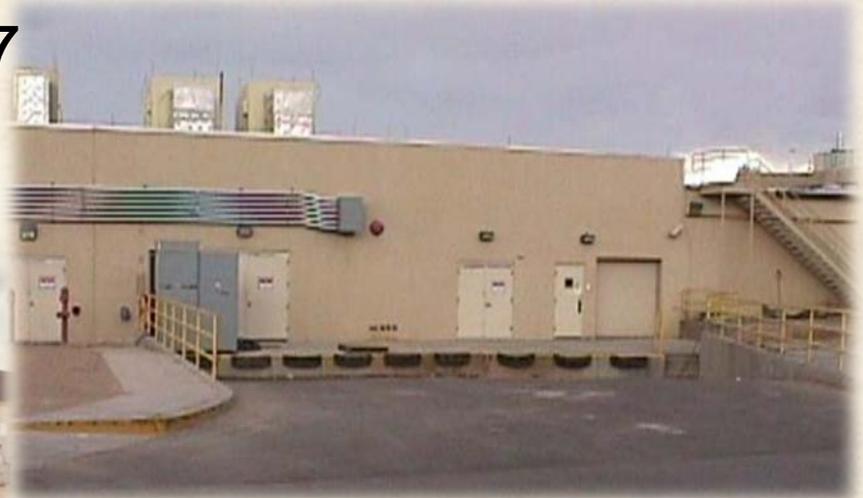
Building 880

- 1953 – Built as warehouse space
- 1965 – Converted to office space: 153,530 GSF
- HVAC
 - Office fans operate 24/7
 - Economizer fans
1-8 nonoperational

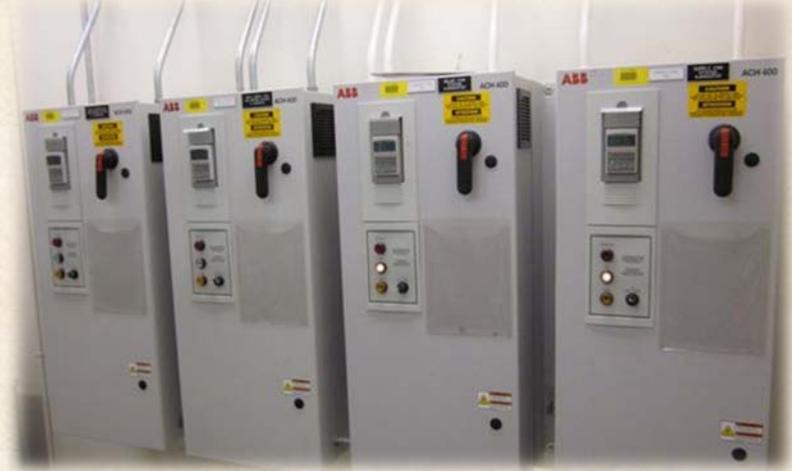
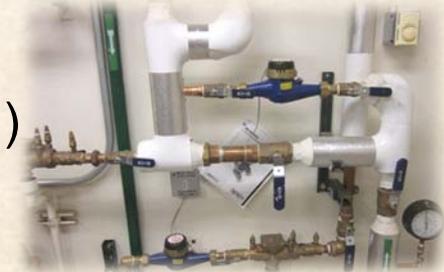
- **Uneven interior temperatures**

- Electric space heaters
- No baseboard heating
- Exterior offices cooler than interior
- Cold outside, zones stayed within DOE range (68 –78)

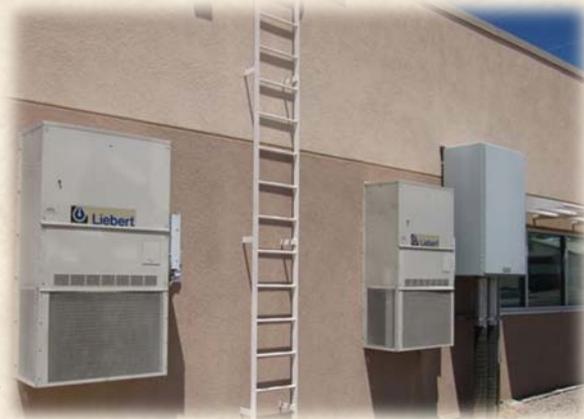
- **AH issues**

- AH1 duct static: reduced from 1.85” to 0.8”
- AH1 linkage to damper blade: repaired
- AH2 did not shut off: reprogrammed

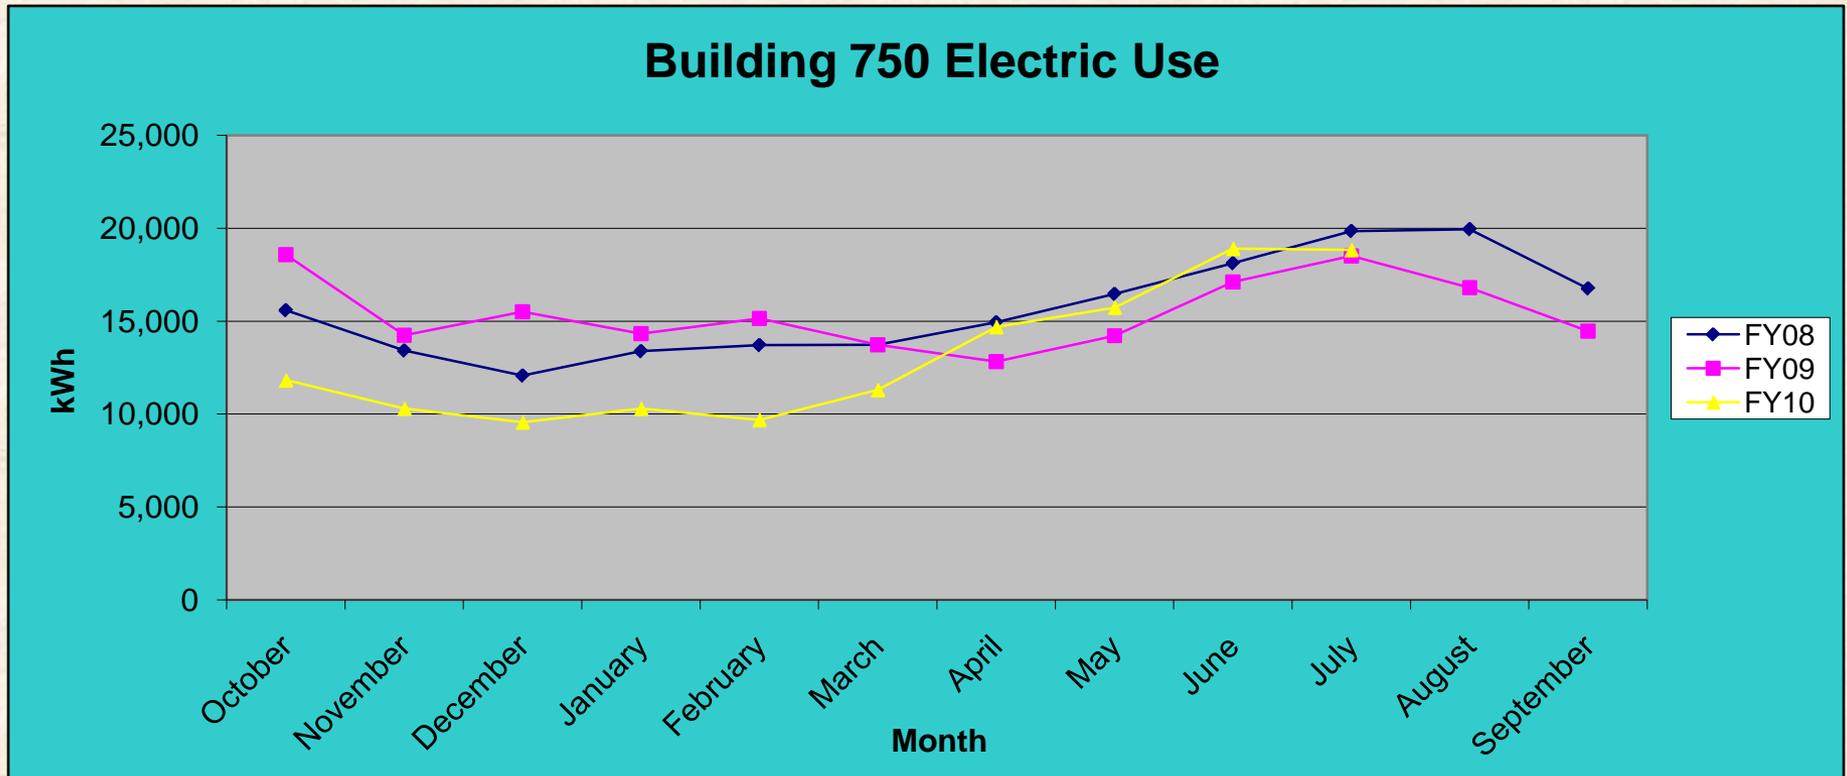
What happened?

1. VAV box 007 damper actuator failed

- Zone ran hot
- Fan VFD static set point at “Max”
- Discharge air set point at “Min”

2. Both AH set points manually overridden

3. Outside mixed-air linkage improperly repaired

4. Building occupancy changed
