• August 15-18, 2010 • Dallas, Texas •
• Dallas Convention Center •

Sandia National Laboratories In-House Retrocommissioning

Michael Rocco, CEM
Facilities Controls System Team Leader

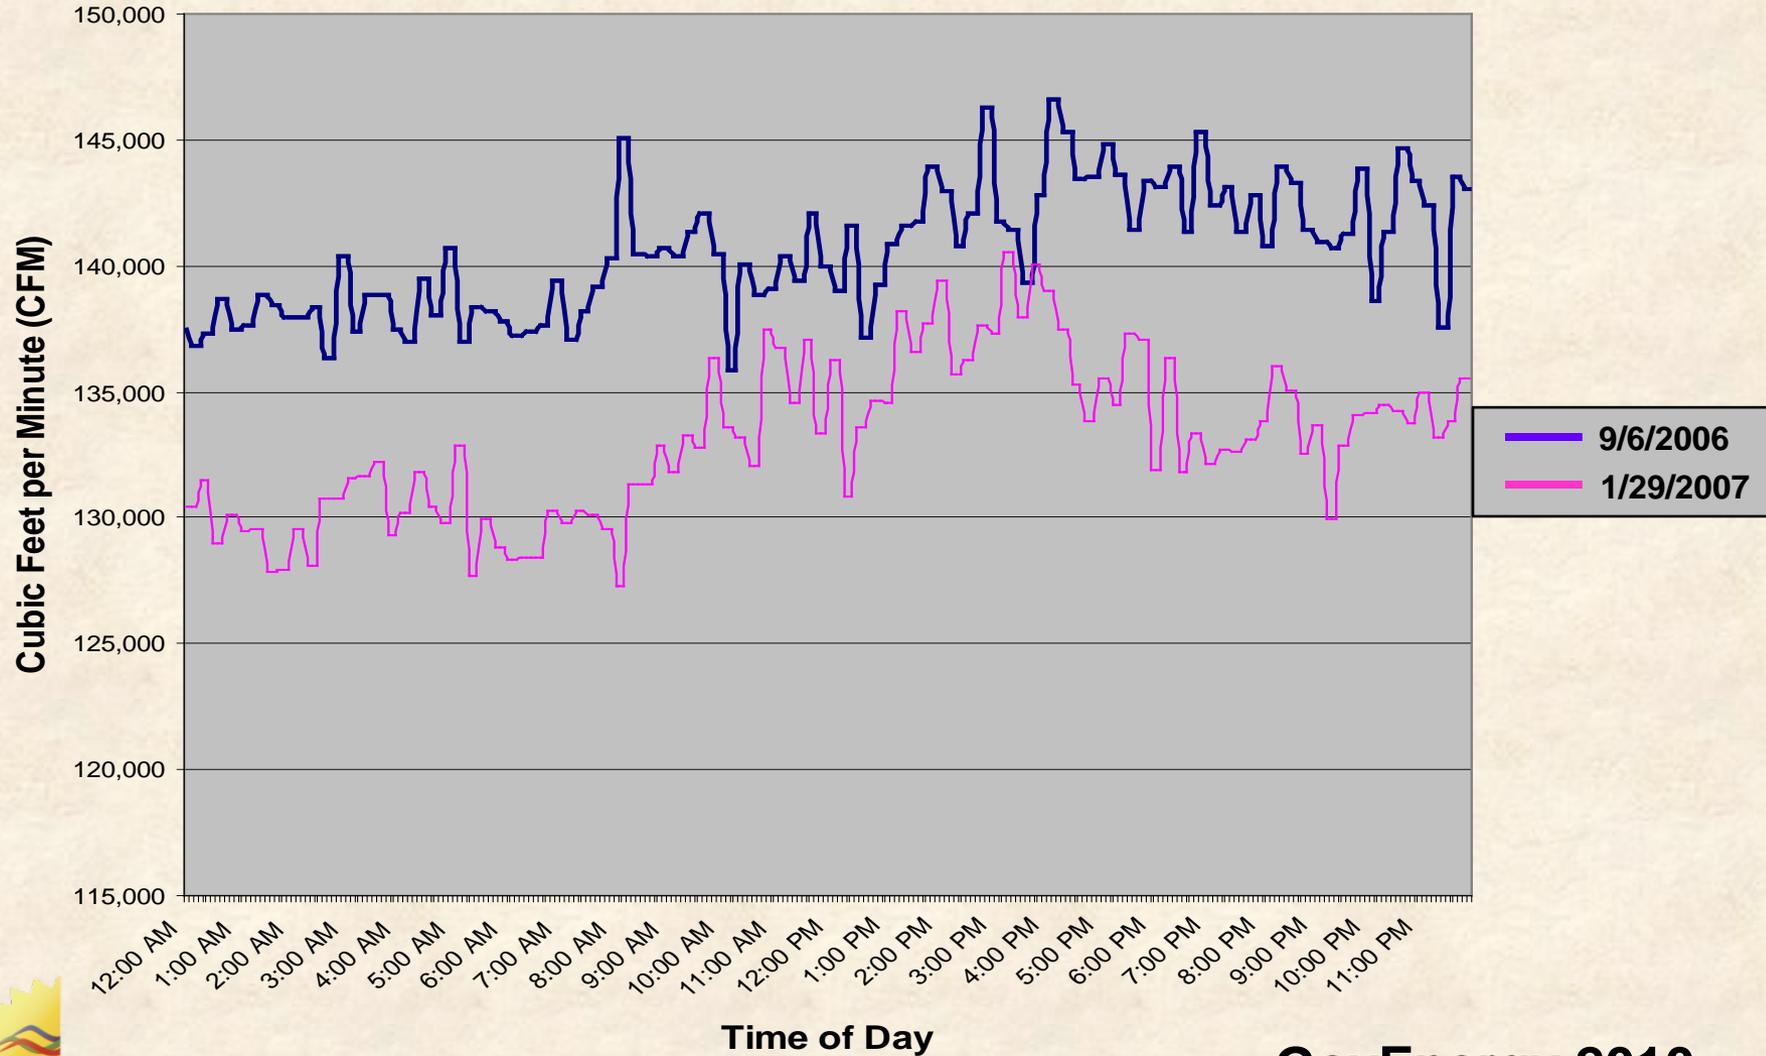
PETL: Exhaust CFM

- High airflows
- Exhaust system

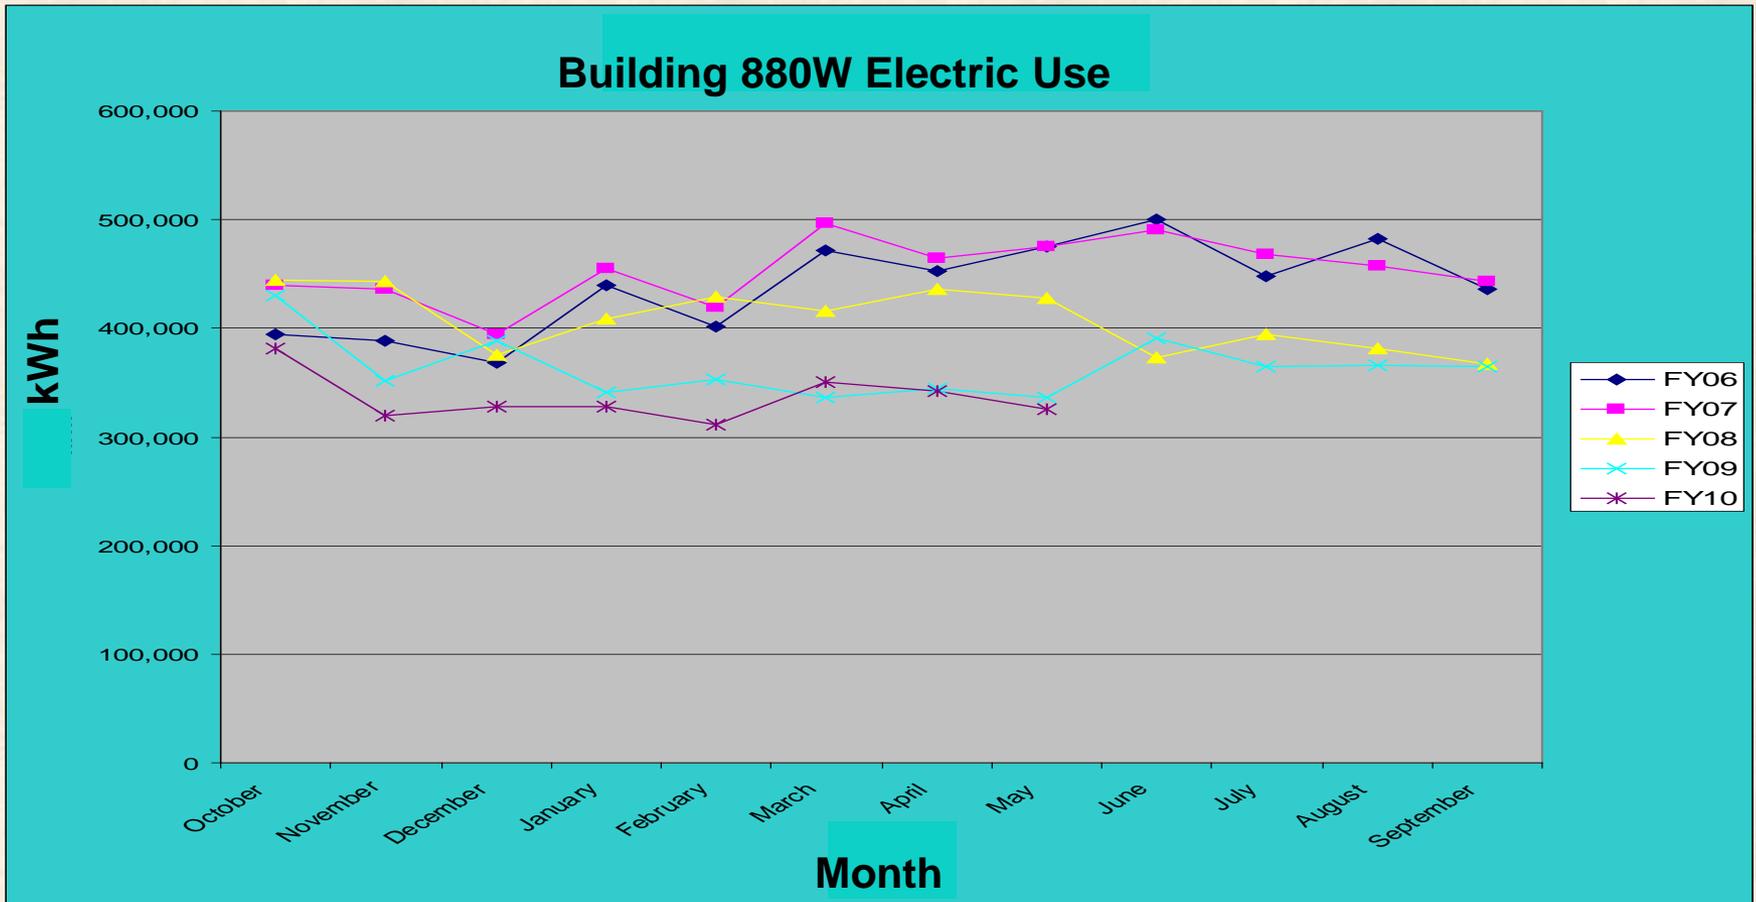
Building 880 Retro-Cx Results

- 1953 – Built as warehouse space
- 1965 – Converted to office space: 153,530 GSF
- HVAC
 - Office fans operate 24/7
 - Economizer fans
1-8 nonoperational

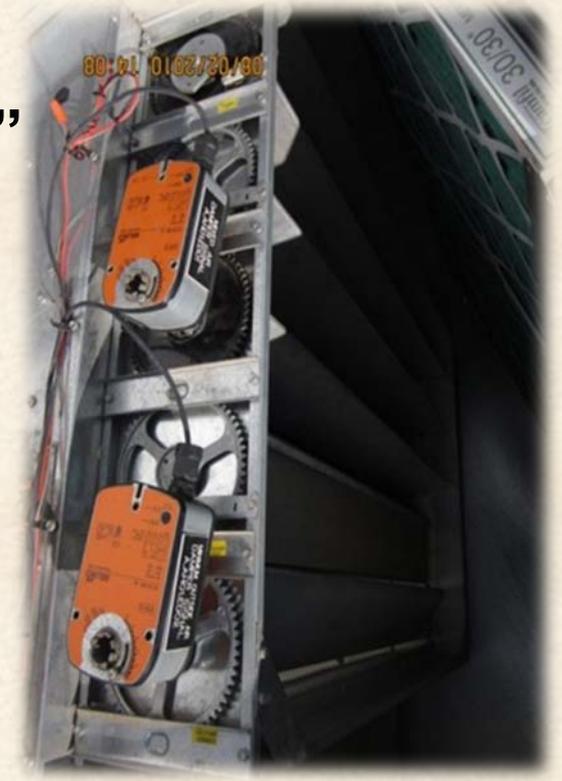
Answer to “*What Happened?*”

1. VAV box 007 damper actuator failed

- Zone ran hot
- Fan VFD static set point at “Max”
- Discharge air set point at “Min”

2. Both AH set points manually overridden

3. Outside mixed-air linkage improperly repaired

4. Building occupancy changed
